# The BC Inspector

## Does your client’s home have a radon problem?

## Six-storey wood frame buildings – Are they safe?

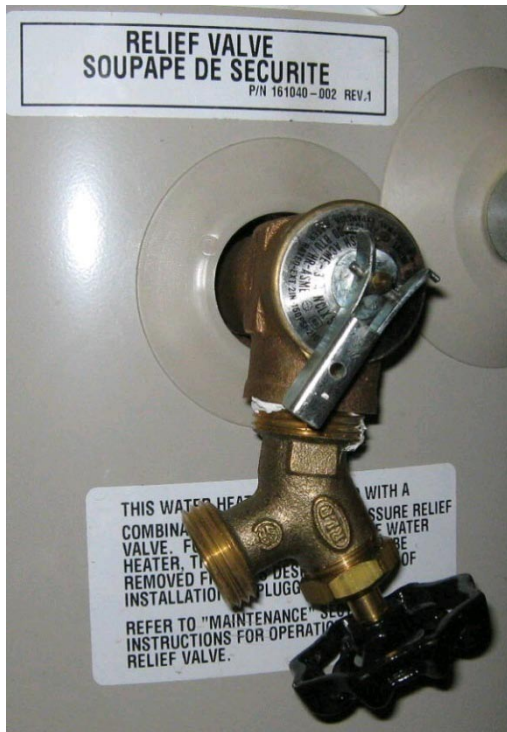
**Left:** *"I finally fixed that leaking hot water tank. I even used Teflon tape for the threads. I should look at becoming a plumber, this is so easy"*

*Well Meaning - but very ignorant home owner  
([see this video](#) for what conditions this home owner has created by defeating the TPR valve.)*
